Significant improvements at Automotive Stamping Plant

Feed Bar Rail Electrical nuisance faults decrease by 95% !!

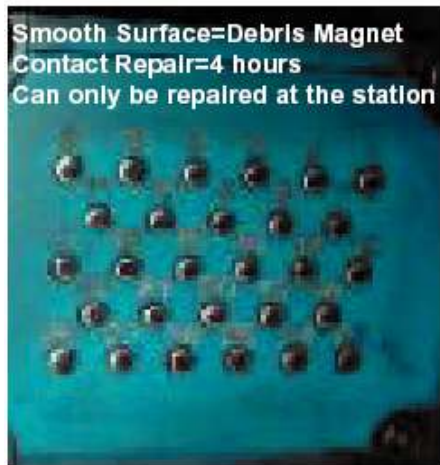
The original feeder bar rail plug connectors that the plant was using had a smooth surface on both the male and female pins. This created a great deal of nuisance downtime faults caused by oil and dirt getting on the mating surfaces of the pins creating intermittent electrical contact. This cost to the plant was approximately 1 Hr. down time per shift on random presses. This meant that mean down time could range up to 3 Hrs. per day per press. To temporarily remedy this, the plant electricians had to PM all the rail bars that were not in use on the bolsters once per day. This meant cleaning the pins with contact cleaner and thoroughly wiping off the smooth pins with a clean cloth. In the event that a broken pin or wire in the plug needed replacing, a 4-hour minimum was required to take the plug apart and struggle to get the 28 pins back together again. This process had to be completed at the press and not on a bench. This was becoming more frequent as the equipment aged.

Old style: Problem

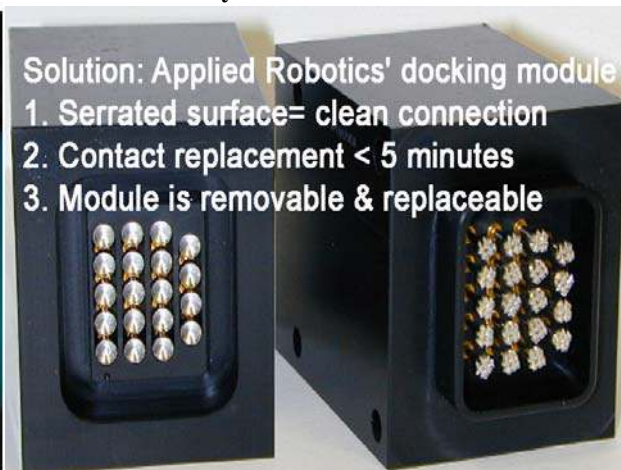
New Style: Solution

Applied Robotics worked closely with plant personnel to redesign the rail plugs blocks to eliminate the problems. The new design included self-cleaning serrated male pogo pins, allowing the rail plug blocks to be replaced in 10 minutes. This is accomplished with a spare block pre-assembled ahead of time on the bench ready for replacement. The repair takes approximately 10 –15 minutes on the bench to replace a broken pin. A male connector is built in to the back of the block for quick disconnection and replacement of the block. To make this application more robust cables in the bar now incorporate robotic cables with matching female connectors.

The Applied Robotics robust modular connection solution has eliminated 95% of the feed rail nuisance faults on the presses.
